# Fire Stopping Survey Report

FS-00014 / Issue 01 / April 2026

## Riverside House

12 Thames Walk, London, SE1 2AA  
Prepared by: Example Fire Ltd

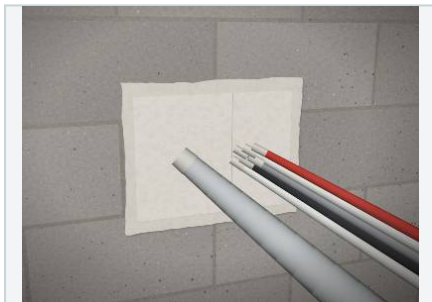
FS-RH-011

Batt installed both faces, ablative coating continuous. Depth confirmed by probe.

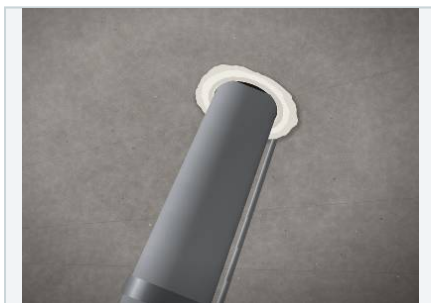
FS-RH-012

**Defect:** Collar absent - combustible pipe sealed with sealant only

Sealant alone will not restrain a combustible pipe at this diameter.

**Recommended action:** Remove the sealant-only detail and install a certified FR collar to the underside, to the tested system for a 110mm combustible pipe through a 200mm slab.

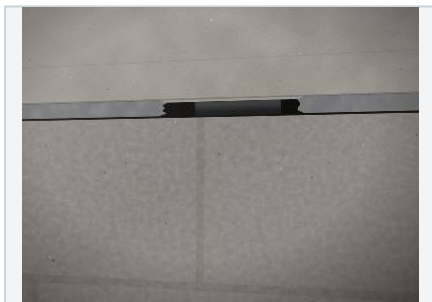
FS-RH-013

**Defect:** Seal not continuous - 180mm section missing

Gap visible above the door head where the blockwork meets the soffit.

**Recommended action:** Clean the joint and re-seal the full length to the tested depth, backed with the specified backing rod.

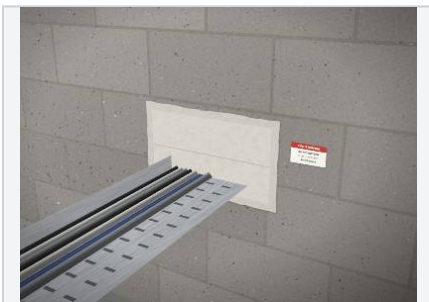
FS-RH-014

Tray sleeved and batted both faces. Identification label applied adjacent to the seal.

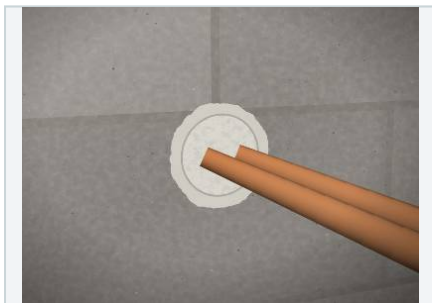
FS-RH-015

**Defect:** Annular gap exceeds the tested maximum for this system

Seal present and sound, but outside the tested field of application.

**Recommended action:** Reduce the opening with the specified backing, or move to a system tested for a 34mm annular gap at this substrate thickness.

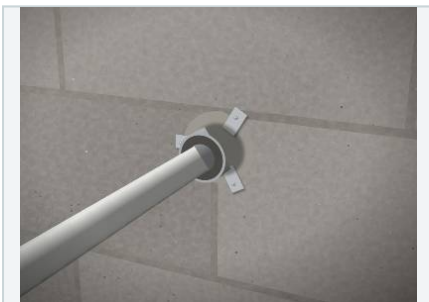
**FS-RH-016**

Collar fitted to the tested system; fixings complete.
