FIRE STOPPING

# Works Completed Report

Riverside House · 12 Thames Walk, London, SE1 2AA

REFERENCE  
FSWC-00018-v2

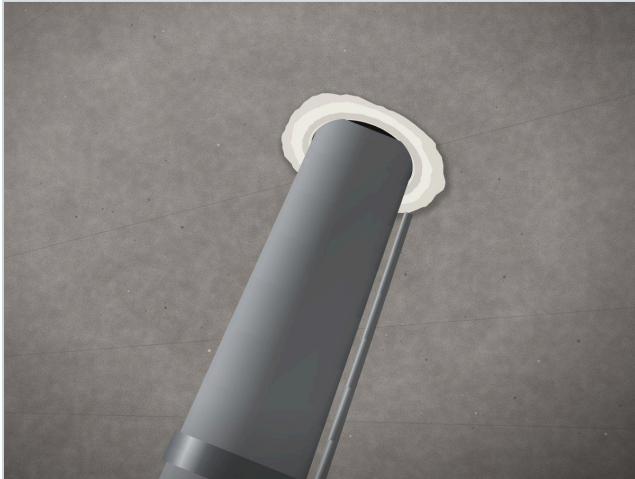
**BEFORE**

| LOCATION | ITEM | SEVERITY | RECORDED COMPLETED | RECORDED BY | COST |
|---|---|---|---|---|---|
| Block A, Level 1 - Corridor ceiling void, grid C4 | Service penetration - soil pipe - Collar absent - combustible pipe sealed with sealant only | High | 23 Apr 2026 | Marta Kowalska | £168.00 |

**Service penetration - soil pipe - Collar absent - combustible pipe sealed with sealant only**

Block A, Level 1 - Corridor ceiling void, grid C4 · Recorded as completed 23 Apr 2026 11:05

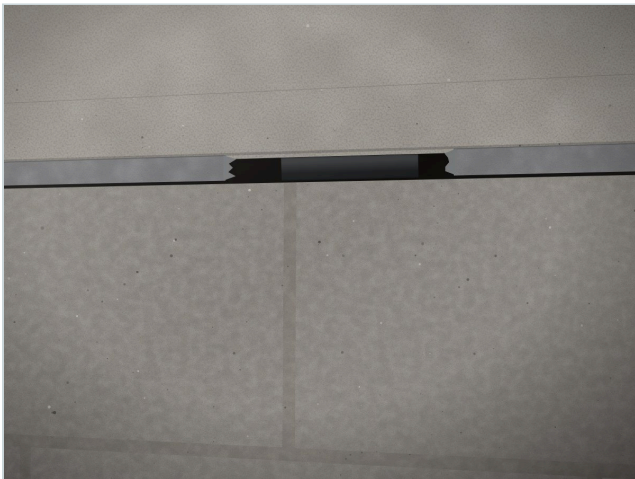
**BEFORE**

| LOCATION | ITEM | SEVERITY | RECORDED COMPLETED | RECORDED BY | COST |
|---|---|---|---|---|---|
| Block A, Level 1 - Flat 11 entrance, head detail | Linear joint seal - Seal not continuous - 180mm section missing | Medium | 24 Apr 2026 | Marta Kowalska | £92.50 |

**Linear joint seal - Seal not continuous - 180mm section missing**

Block A, Level 1 - Flat 11 entrance, head detail · Recorded as completed 24 Apr 2026 11:05

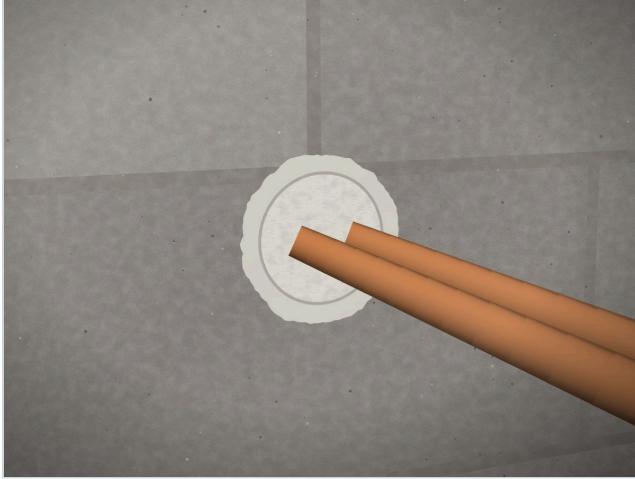
**BEFORE**

| LOCATION | ITEM | SEVERITY | RECORDED COMPLETED | RECORDED BY | COST |
|---|---|---|---|---|---|
| Block A, Level 1 - Plant room, west wall | Service penetration - copper pipework - Annular gap exceeds the tested maximum for this system | Low | 25 Apr 2026 | Marta Kowalska | £134.00 |

**Service penetration - copper pipework - Annular gap exceeds the tested maximum for this system**

Block A, Level 1 - Plant room, west wall · Recorded as completed 25 Apr 2026 11:05
